STEP WELL STORAGE COMPARTMENT COVER INSTALLATION FOR DODGE SPRINTER CHASSIS

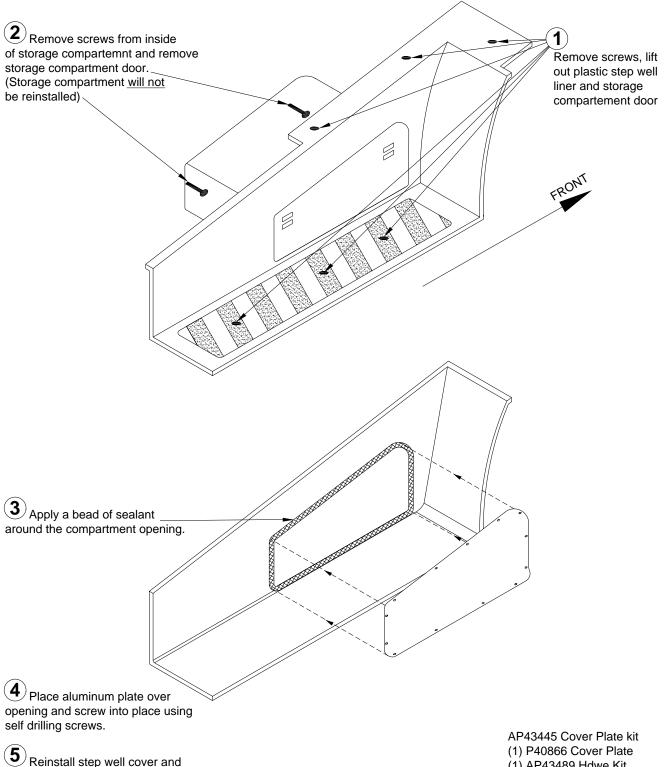
On some Sprinter chassis the storage compartment in the right step well must be removed to allow jacks to be installed.

Reinstall step well cover and storage compartment door.

(1) AP43489 Hdwe Kit
